# X-ray inspection

## MiPlaza Materials Analysis

Technical Note 14

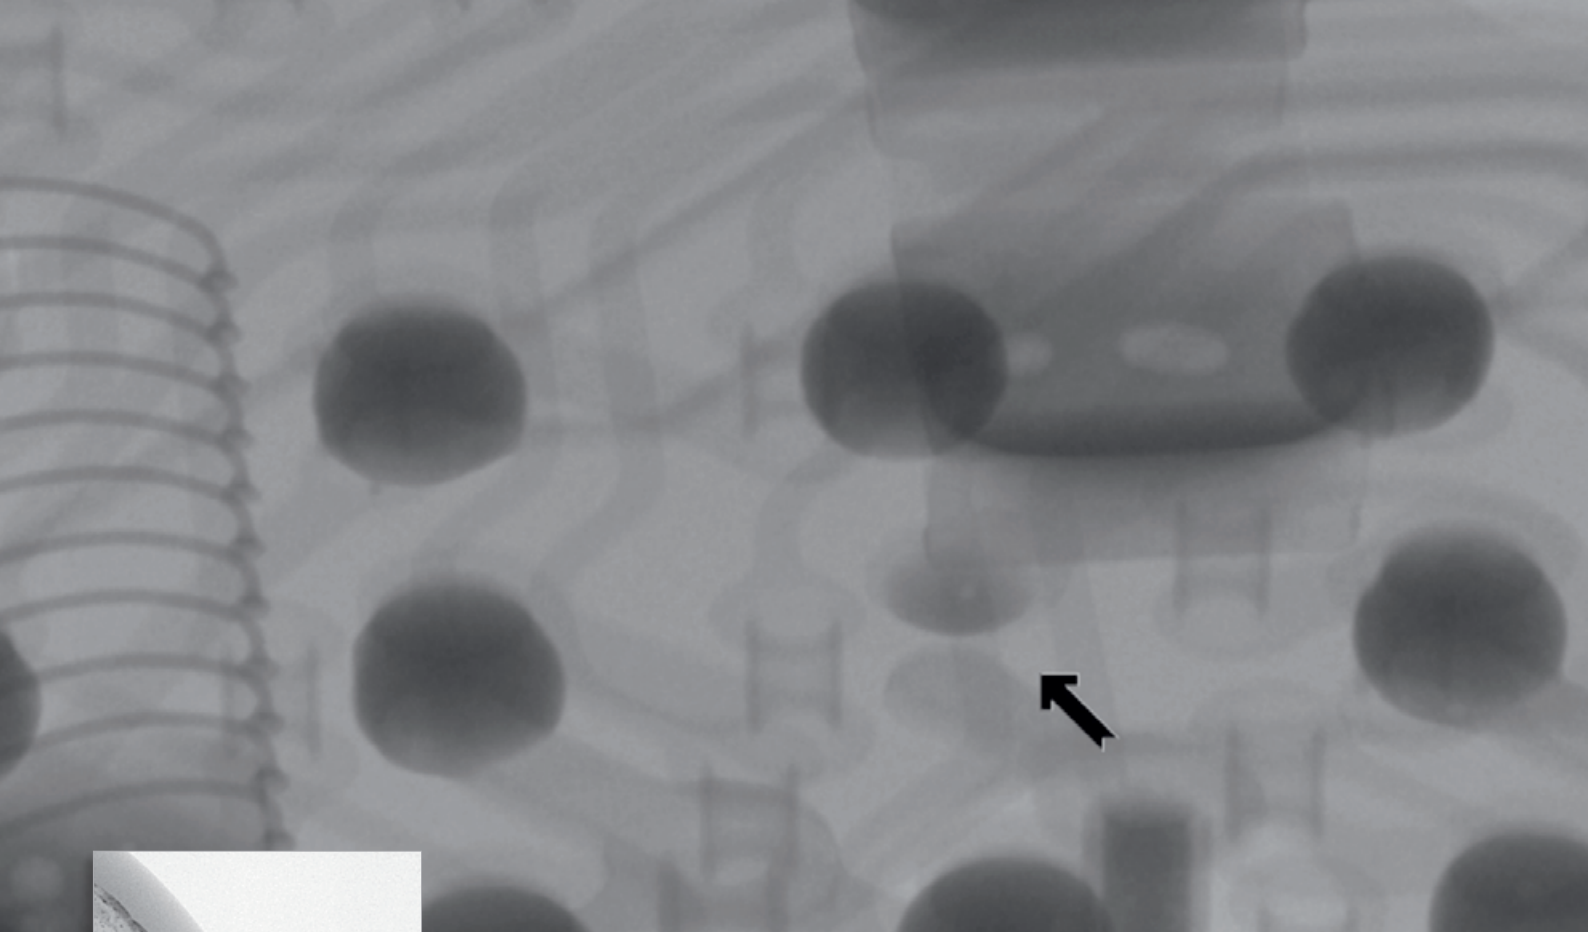
Optical photography image and X-ray images of a Printed Circuit Board (PCB). Inspection shows the malfunctioning component: the crack in the capacitor is clearly visible in the X-ray images.

In pseudo 3-D, the detector is tilted with respect to the sample while imaging the sample in real-time. In this way, 3-D information is obtained on internal structures of the sample (see image on the front page). Parts of the sample that are first blocked by other parts in 2-D mode become visible now. In the front page image, interconnects below solder dots can be checked on their connectivity. (The arrow points at a missing interconnect).
